Specialty Manufacturing, Inc.

Technical Bulletin

THA-0001-00

**Replacement Procedure for
Transpec Power Vent:
Fan Grille Well Nut Replacment**

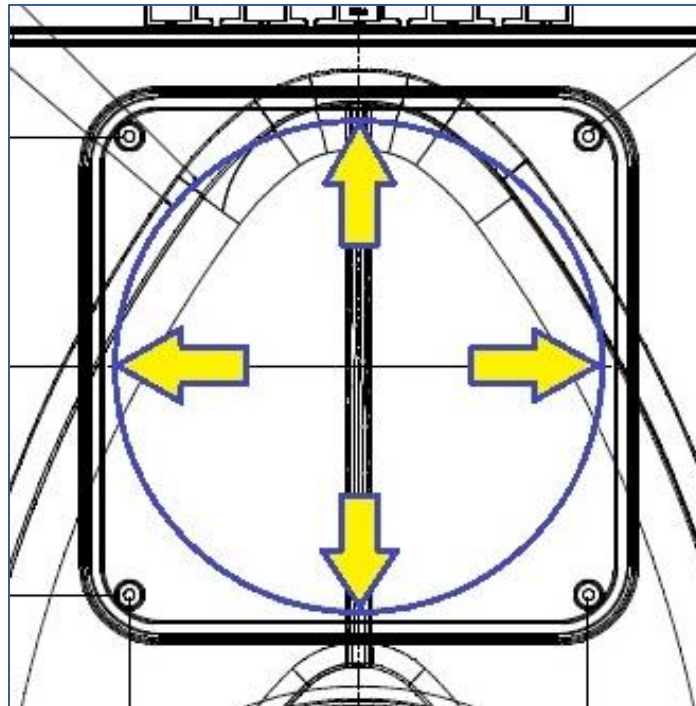
This technical bulletin provides information regarding replacement of the (4x) well nuts that are used to fasten the fan grille assembly to the hatch lid. This will address the issue of fan assembly falling out once installed.

1. Disconnect the bus' negative battery lead.
2. Disconnect the fan's wire leads.
3. Remove well nuts that have pulled loose of hatch lid. These should be attached to the fan grille. Remove the Philips head machine screws, and the well nut will be released.
4. Verify dimension of fan assembly hole. Diameter should be 10.25".
