Specialty Manufacturing, Inc.

Technical Bulletin

AXA-0001-00

AIR LEAK REPAIR PROCEDURE: INTEGRATED AIR CROSS ARM

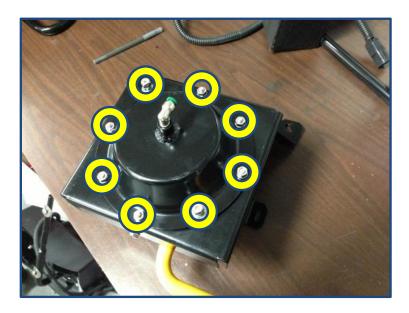
Purpose: This technical bulletin provides information regarding the procedure for repairing an air leak between the spring cover and the mounting bracket.

- 1. Disconnect the air input from the back of the unit.
- 2. Remove the Poly-rod from the base unit's hinge arm.
- 3. Disconnect the base unit from the bumper of the bus.
- 4. Remove 8 bolts securing the spring cover to the mounting bracket. Remove cover.

- 5. Install additional gasket (002124) over previously installed gasket (002124).
- If the original gasket is damaged it should be replaced at this time.
- If done correctly you currently should have (2x) 002124 gaskets on the mounting bracket.
