Pretoria - Tech Talk # 2

Date: 2/8/2006

Topic: Extinguishable & Dimmable Ballast / High Output (HO) Lamp Tubes

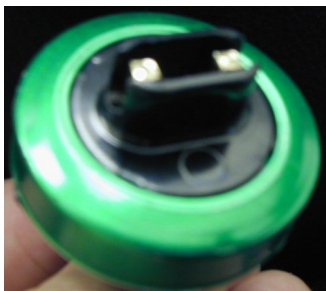
HO Lamp End

HO lamp tubes are used in conjunction with extinguishing and dimmable ballast; HO lamp tubes are bi-pin as shown below rather than single pin. Bi-pin configurations are used in order to provide a limited but constant amount of power to the lamp tube filaments keeping them warm and ready for full power when required.

The installation of an HO lamp tube into a HO socket must be done with care by properly aligning the lamp end with the socket. It is important when installing lamp tubes to inspect both the lamp ends for damage and the lamp sockets for debris or bent contact pins before installation. Always insert the lamp tube in the floating (push-spring) socket first and then the fixed socket. Never force or twist an HO lamp tube into the socket as these actions may crack the RDC Bay (recessed double contact bay).

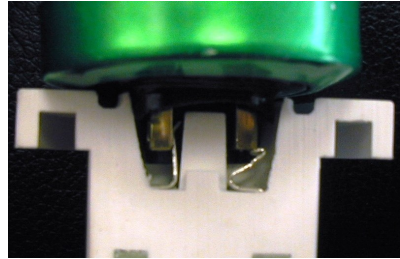
Damaged RDC Bay and
Damaged Socket Receptacle

The RDC Bay is normally molded from Phenolic resins due to their good dielectric properties, heat resistance and flammability characteristics. Unfortunately, molded Phenolic resins are inherently brittle. The RDC Bay not only protects the pins from damage, but most importantly they aid in keeping the lamp ends seated properly in the socket. HO lamp tubes with a cracked RDC Bay should not be used as the lamp will easily turn in the fixture causing intermittent or no contact with the lamp pins and socket receptacles.

Debris of the HO lamps RDC Bay can become lodged in the HO socket, any pieces of broken RDC Bay should be completely removed from the socket before installation of a new HO lamp tube. Inserting a new HO lamp in an HO socket with RDC Bay debris left in the socket can damage the new lamp tubes RDC Bay and HO socket receptacle pins causing a poor or non-existent connection. Never force or twist HO lamp tubes into their mating sockets and always inspect both the lamps ends and socket before installation.

We ask that if you suspect that extinguishing or dimming ballast is malfunctioning that you shut off the power to the lights, remove the HO lamp completely from the sockets and inspect both the lamps ends and socket pins for any damage. If damage is present, replace the HO lamp or socket before changing the ballast.
