# Pretoria - Tech Talk # 2

Topic: Extinguishable & Dimmable Ballast / High Output (HO) Lamp Tubes

Pretoria Transit Interiors, Inc. has issued this Tech Talk to keep our customers informed on issues pertaining to passenger interior fluorescent light systems.

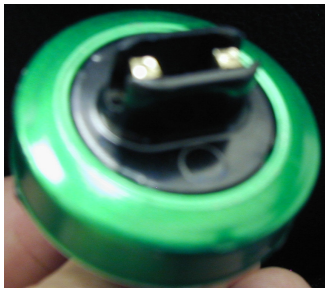
Ho lamp tubes are used in conjunction with extinguishing and dimmable ballast; HO lamp tubes are bi-pin as shown below rather than single pin. Bi-pin configurations are used in order to provide a limited but constant amount of power to the lamp tube filaments keeping them warm and ready for full power when required.

HO Lamp End

The installation of an HO lamp tube into a HO socket must be done with care by properly aligning the lamp end with the socket. It is important when installing lamp tubes to inspect both the lamp ends for damage and the lamp sockets for debris or bent contact pins before installation. Always insert the lamp tube in the floating (push-spring) socket first and then the fixed socket. Never force or twist an HO lamp tube into the socket as these actions may crack the RDC Bay (recessed double contact bay).

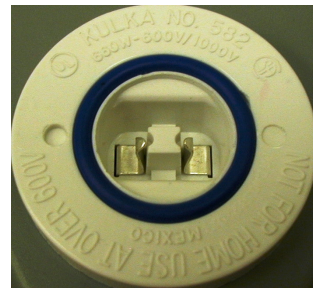
HO Socket Receptacles

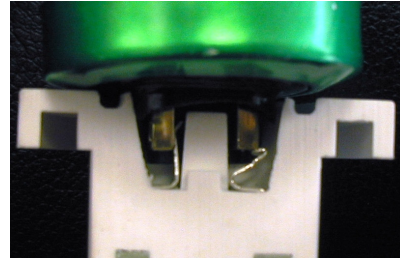
The RDC Bay is normally molded from Phenolic resins due to their good dielectric properties, heat resistance and flammability characteristics. Unfortunately, molded Phenolic resins are inherently brittle. The RDC Bay not only protects the pins from damage, but most importantly they aid in keeping the lamp ends seated properly in the socket. HO lamp tubes with a cracked RDC Bay should not be used as the lamp will easily turn in the fixture causing intermittent or no contact with the lamp pins and socket receptacles.

Damaged RDC Bay and Damaged Socket Receptacle

Debris of the HO lamps RDC Bay can become lodged in the HO socket, any pieces of broken RDC Bay should be completely removed from the socket before installation of a new HO lamp tube. Inserting a new HO lamp in an HO socket with RDC Bay debris left in the socket can damage the new lamp tubes RDC Bay and HO socket receptacle pins causing a poor or non-existent connection. Never force or twist HO lamp tubes into their mating sockets and always inspect both the lamps ends and socket before installation.

We ask that if you suspect that extinguishing or dimming ballast is malfunctioning that you shut off the power to the lights, remove the HO lamp completely from the sockets and inspect both the lamps ends and socket pins for any damage. If damage is present, replace the HO lamp or socket before changing the ballast.
