TECHNICAL BULLETIN- #A1002
SUBJECT: **TRANSPEC HATCH HANDLE REVISION**
Effective Date: 09/08/10

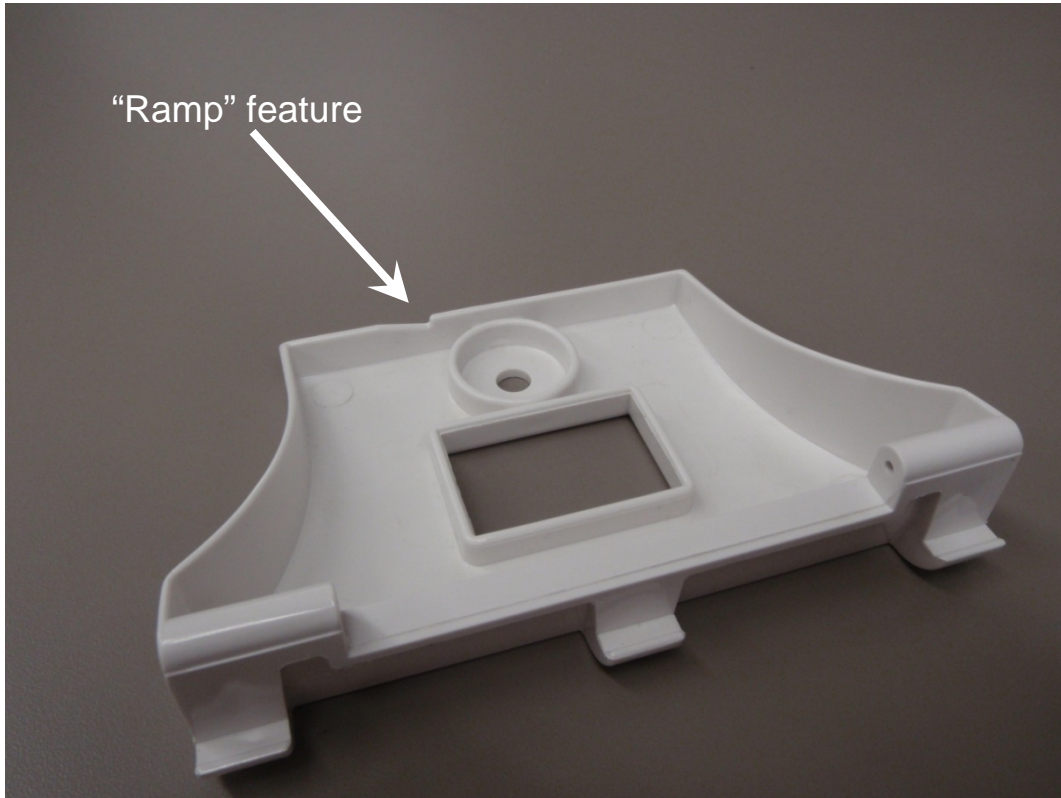
Recently SMI improved the design of the Transpec Vandal Lock hatches. The Vandal Lock system features a cam style microswitch which interacts with the release mechanism to prevent the opening of the hatch lid when locked. The cam lock slides underneath the handle (handle shown below). Occasionally, the cam could be difficult to rotate into the locked position. This design change addresses this situation.

The improvement is a small “ramp” feature on the back side of the handle. This feature allows the cam lock to gradually connect with the handle thus improving the overall alignment of the handle and the cam lock.

Previously produced hatches that do not have this ramp feature are still considered fully functional. This change does not affect the normal “release operation” of the handle mechanism. In the future, the ramp feature will be present in all styles of Transpec hatches regardless of whether it is a Vandal Lock hatch or not.

Please note that the change will not typically be noticed as the handle is covered by the handle shield in the final hatch assembly. However, it might be noticed and questioned in a repair type situation.
